Release Notes for the Catalyst 3750, 3560, 2970, and 2960 Switches, Cisco IOS Release 12.2(44)SE and Later

Revised September 9, 2009

Cisco IOS Release 12.2(44)SE and later runs on all Catalyst 3750, 3560, 2970, and 2960 switches and on Cisco EtherSwitch service modules.

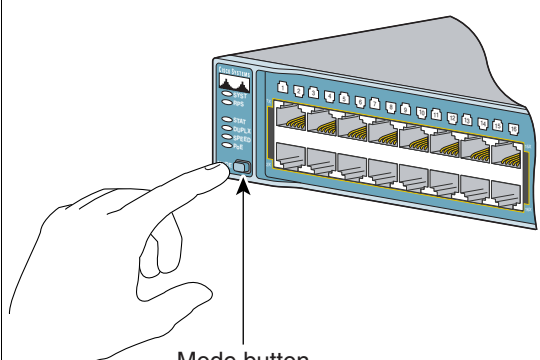
| Step 5 | <p>Press and hold the Mode button for 3 seconds. When all of the LEDs left of the Mode button turn green, release the Mode button.</p> <p>If the LEDs left of the Mode button begin to blink after you press the button, release it. Blinking LEDs mean that the switch has already been configured and cannot go into Express Setup mode. For more information, see the “Resetting the Switch” section.</p> | <p>Mode button</p> |

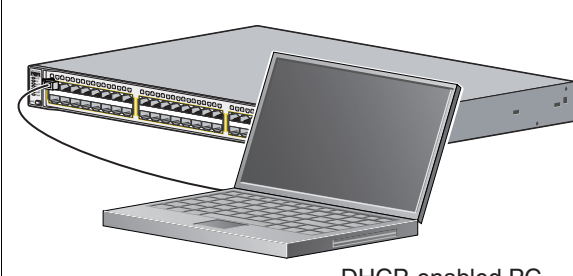
| Step 7 | <p>Connect a Category 5 Ethernet cable to any 10/100 or 10/100/1000 Ethernet port on the switch front panel.</p> <p>Connect the other end of the cable to the Ethernet port on your PC.</p> | <p>DHCP-enabled PC</p> |
